DAVID EVANS
AND ASSOCIATES INC.

December 1, 2009

SUBJECT: COURTHOUSE SQUARE QUARTERLY BUILDING-MONITORING PROGRAM

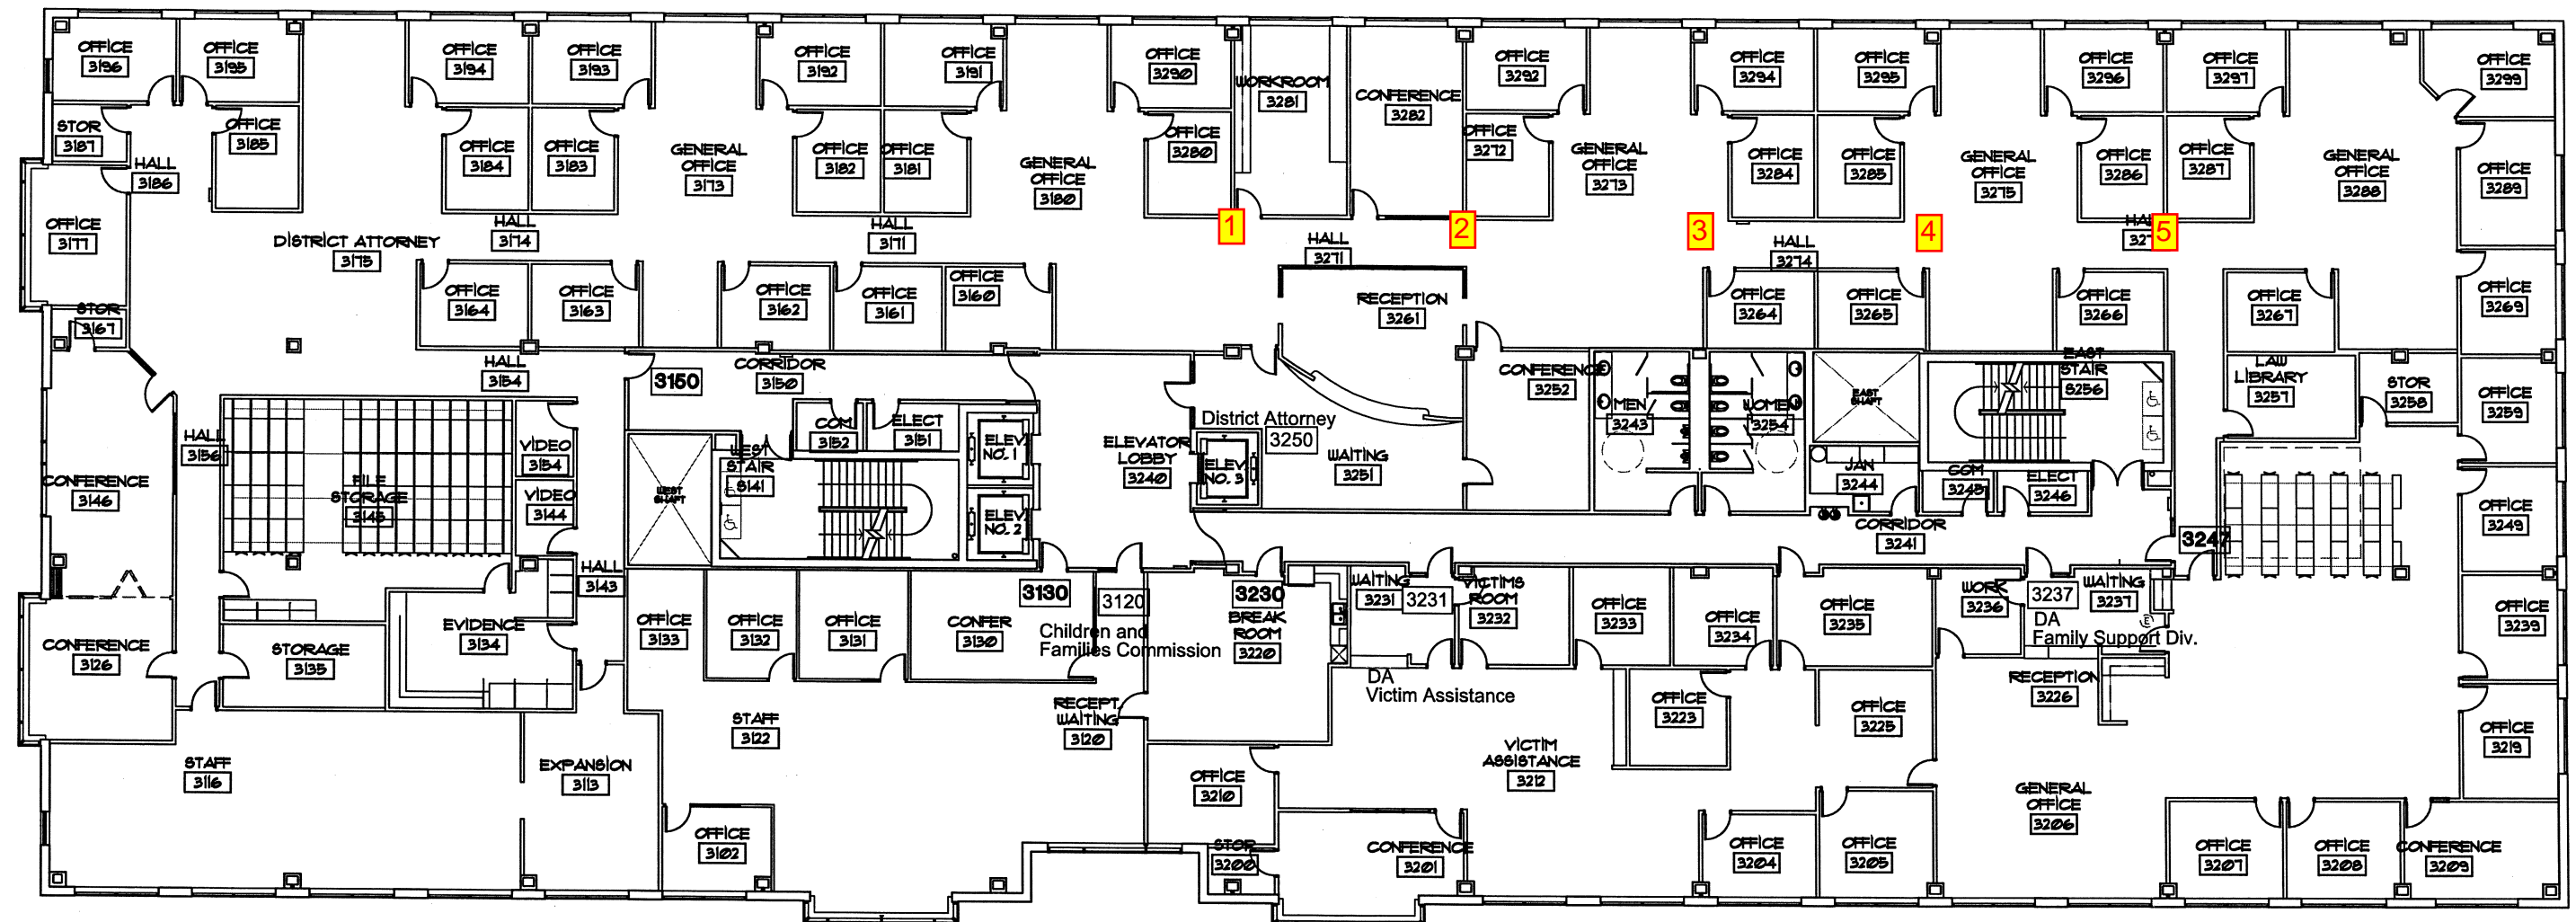
CS-3

3rd Floor Location	Aug. 31, 09 Deflection (in.)	Nov. 26, 09 Deflection (in.)	Δ Deflection (in.)
1	1.40	1.50	0.10
2	2.15	2.15	0.00
3	2.15	2.10	-0.05
4	2.35	2.30	-0.05
5	2.10	2.20	0.10

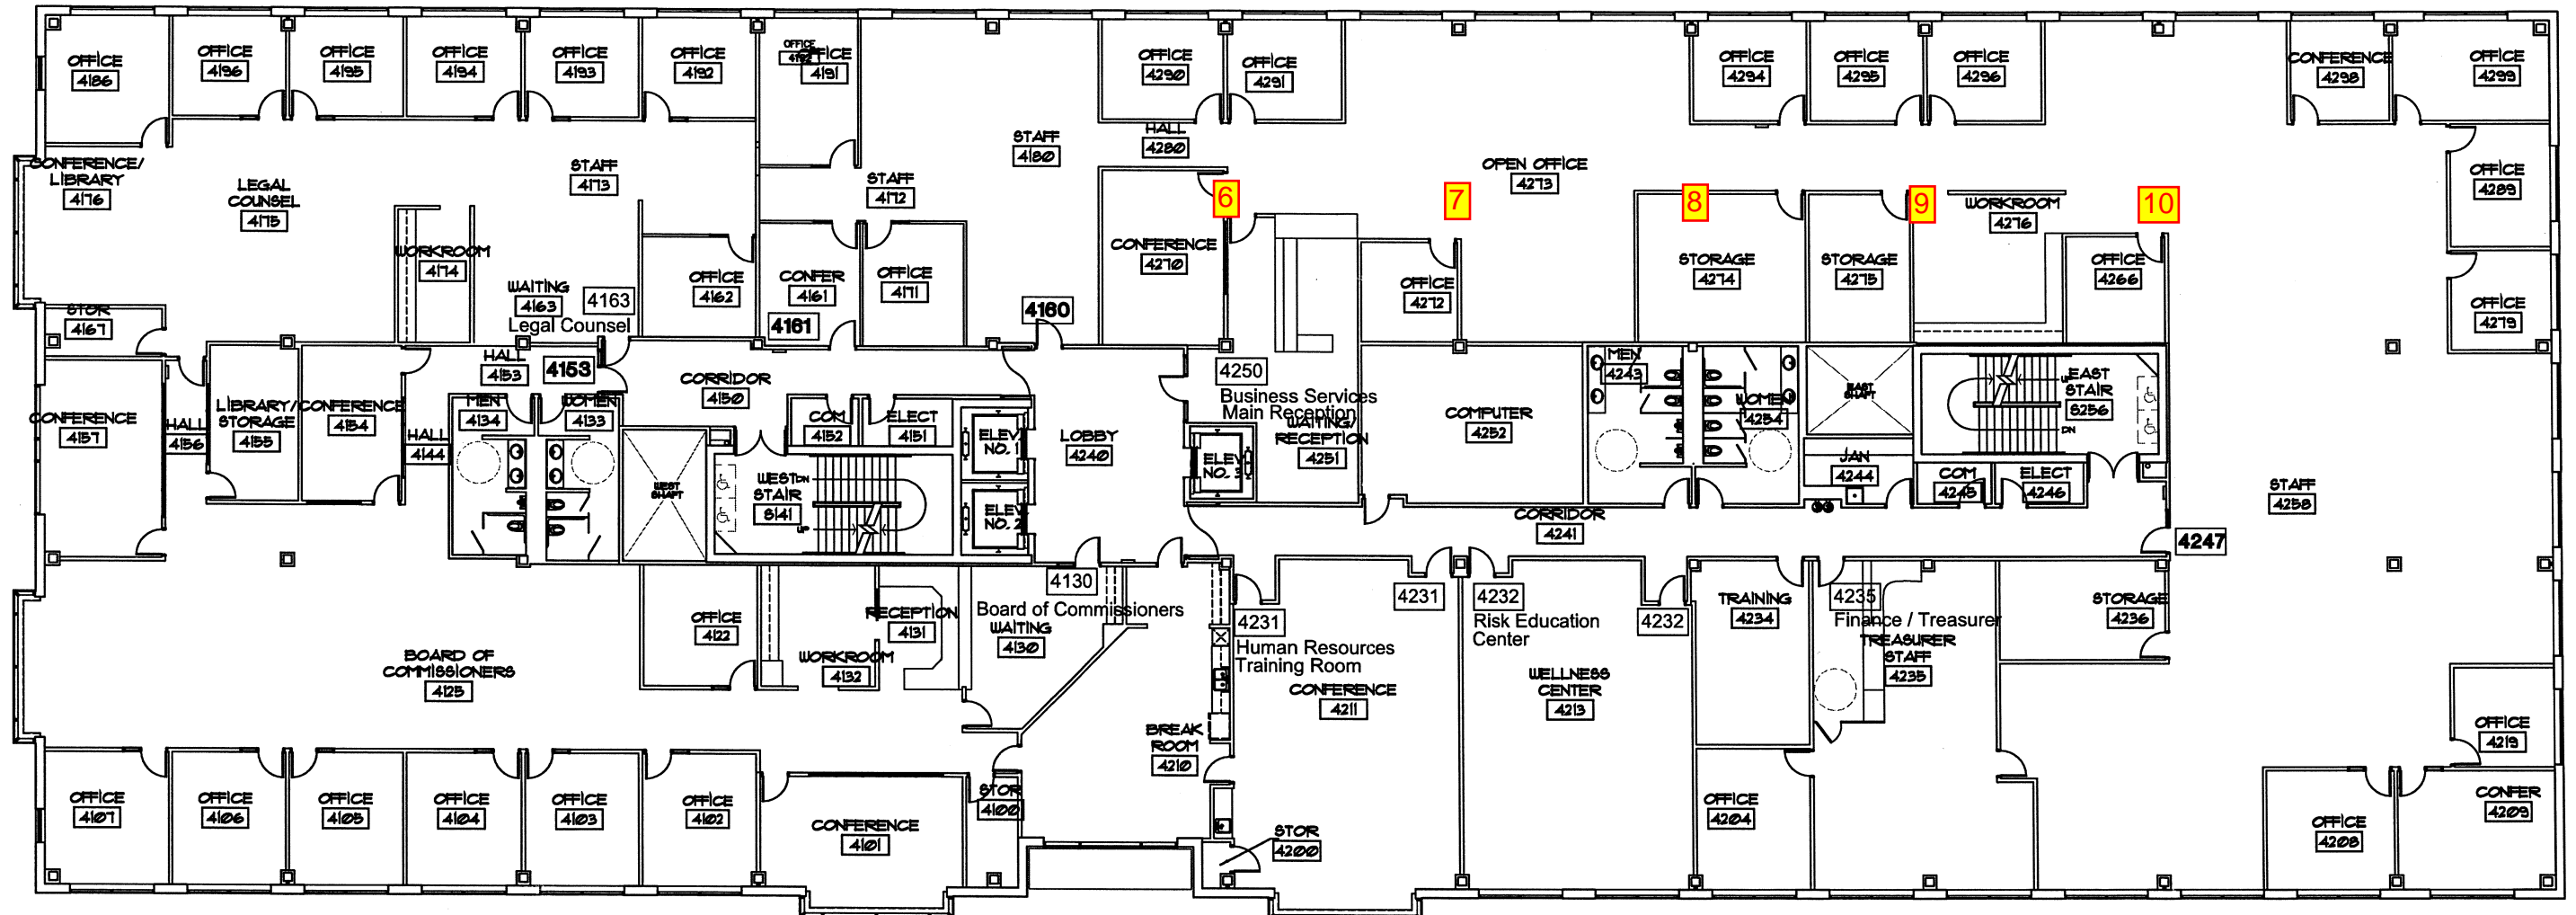
CS-4

4th Floor Location	Aug. 31, 09 Deflection (in.)	Nov. 26, 09 Deflection (in.)	Δ Deflection (in.)
6	1.20	1.25	0.05
7	1.35	1.45	0.10
8	1.70	1.75	0.05
9	2.25	2.25	0.00
10	1.50	1.50	0.00
